Carlsbad Desalination Plant Wedgewire Screen Pilot Study August 31, 2022

Phase 3 – Wedgewire Screens

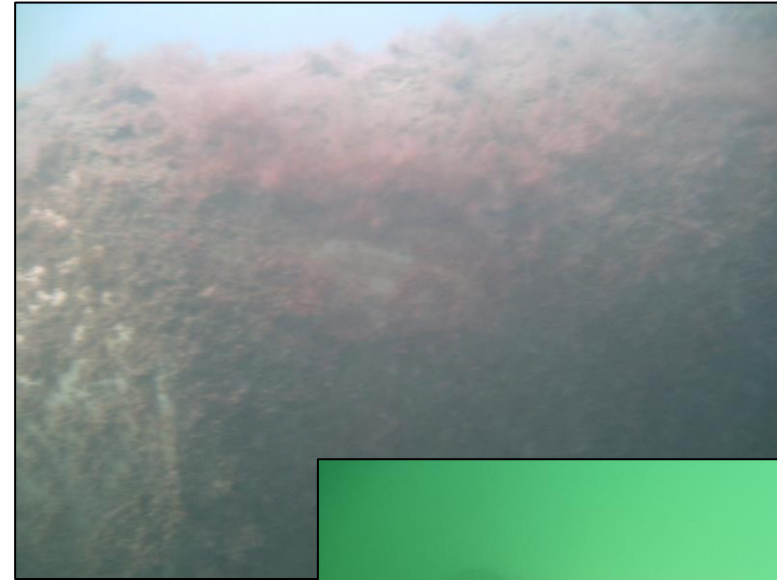
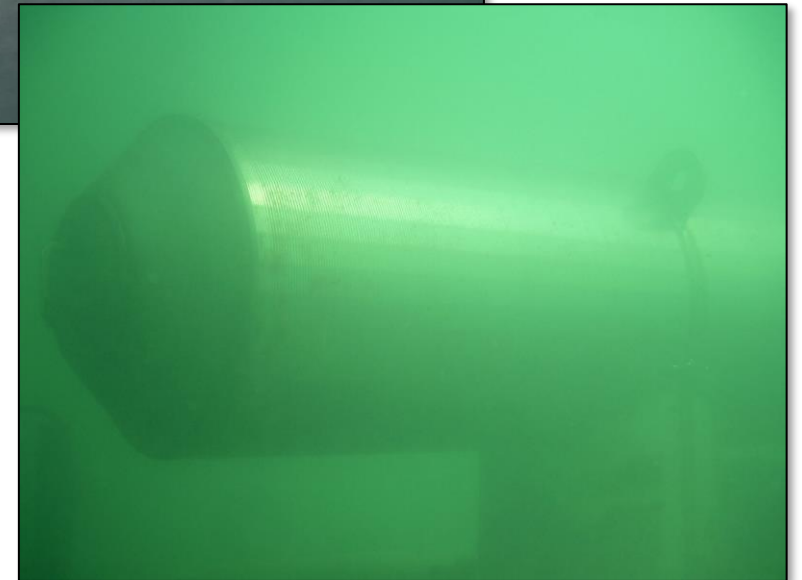
Passive WWS (Super Duplex Stainless)

- Exterior fouling accumulated within one month (**Note:** screen is not copper nickel)
 - Exterior fouling was soft growth and was easily removed manually by divers
 - Airburst was effective for free-floating debris, but did not clear attached biofouling
- Interior inspection began after 6 months of operation
 - Substantial interior fouling accumulated since interior not cleaned monthly – airburst was operating for most of the 6-mo period
 - Progressed from soft to hard growth (mussels)
 - After monthly interior cleaning began, interior fouling was soft growth and was easily removed by divers (manually/with pressure washer)

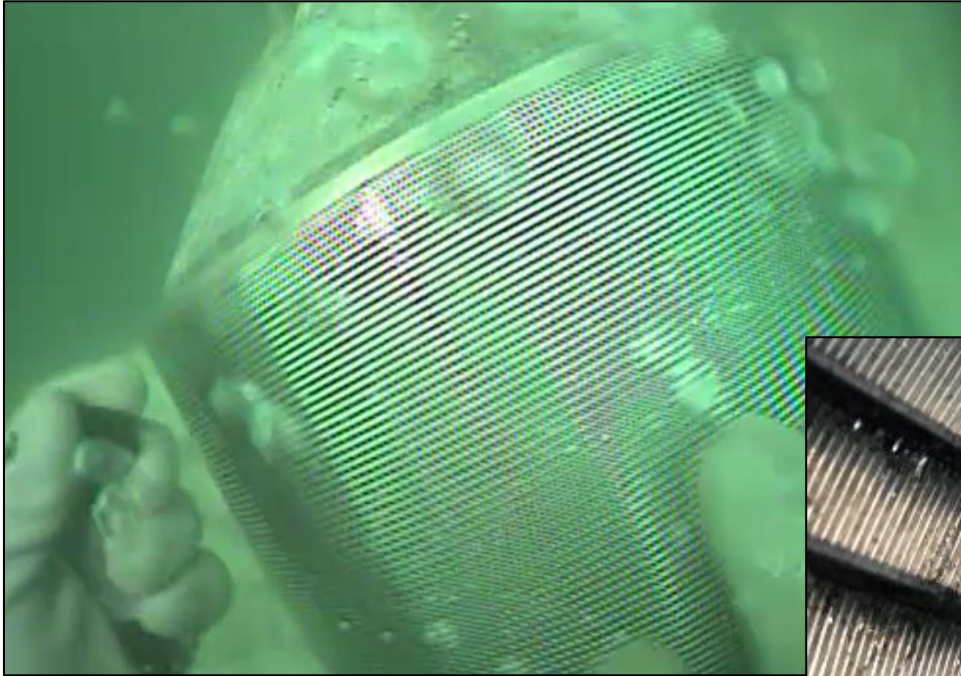
Passive WWS after thorough cleaning

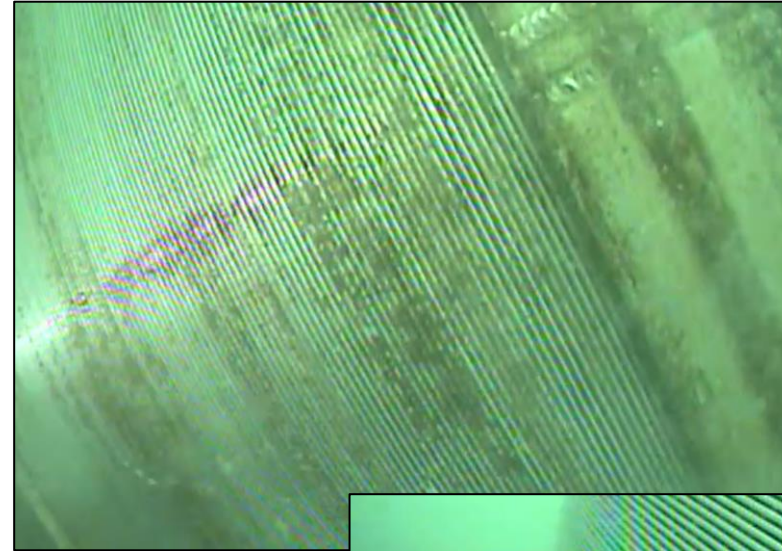
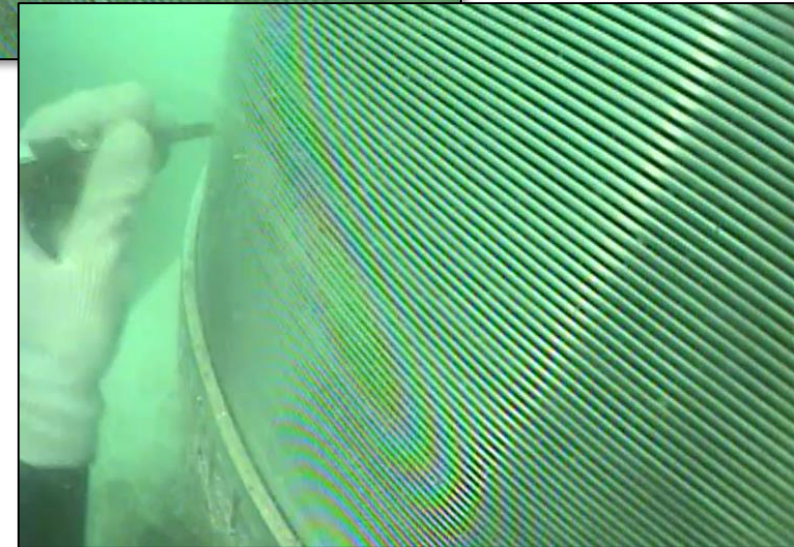
Active WWS (Super Duplex Stainless)

- Exterior fouling was controlled by brushes and rotation of screen
 - No noticeable accumulation over duration of study at cleaning frequency of 3 cleaning events/day
 - Brush contact must be assured - adjust as needed
- Interior fouling of the screen surface (which is brushed) was light at the 6-month inspection point
