SUBJECT: Cover Letter for Future Supply Action (FSA) Funding Program for The
Moorpark Stormwater Diversion and Groundwater Recharge Project Study

Arroyo Las Posas Stormwater Diversion Feasibility Study and Percolation Test

VENTURA COUNTY WATERWORKS DISTRICT NO. 1
MOORPARK

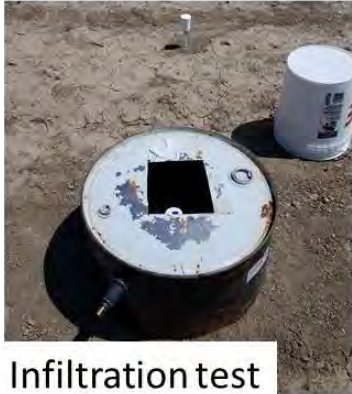
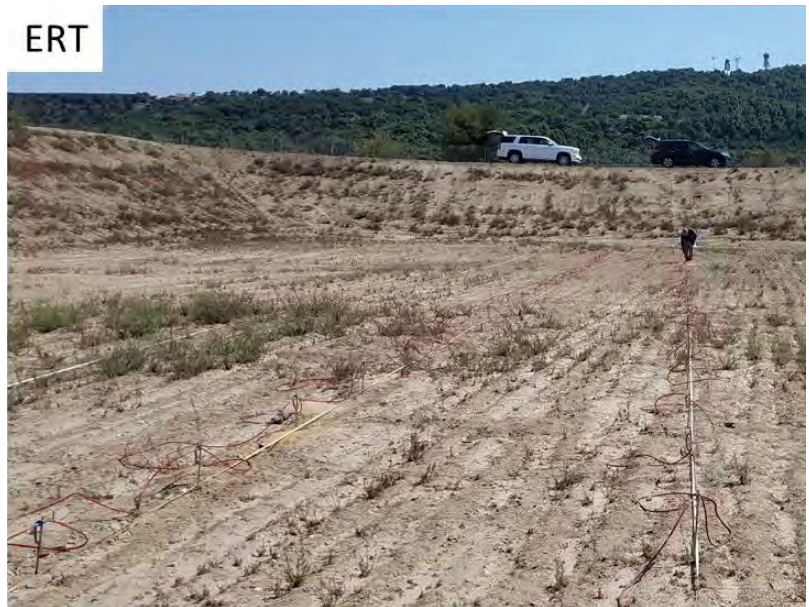
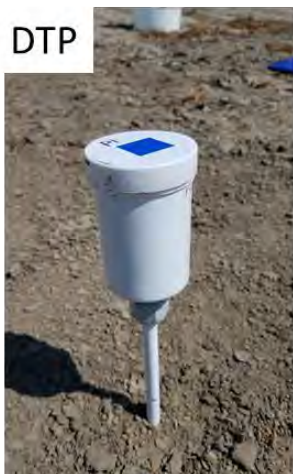
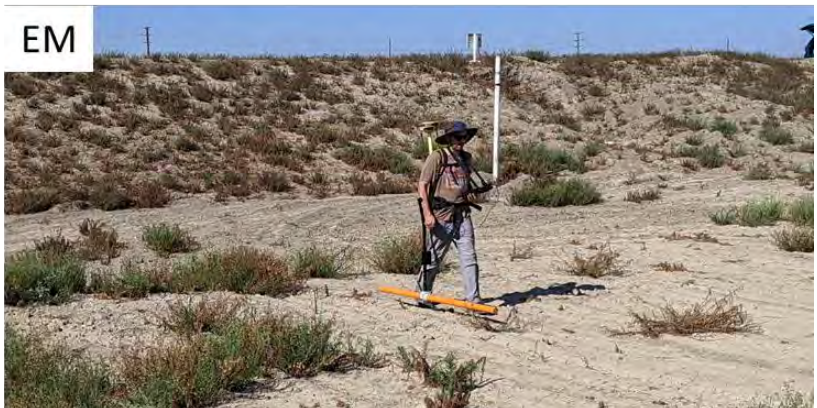
Figure 3. Characterization methods include EMI (EM photo), ERT, DTP, and modified seepage meters for infiltration tests.

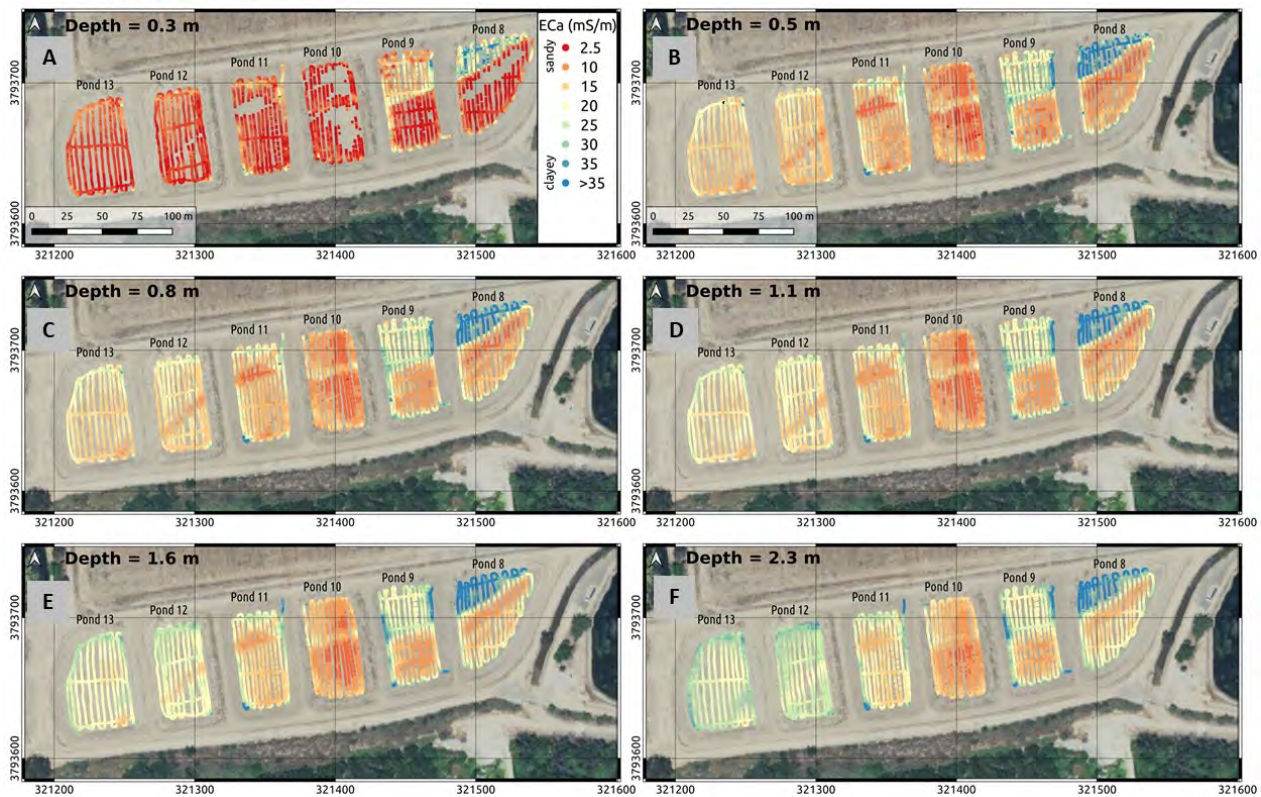
Figure 5. EMI apparent conductivities collected in all ponds (P8-P13) at six coil spacings relating to effective investigation depths of 0.3, 0.5, 0.8, 1.1, 1.6, and 2.3 m. High electrical conductivity (blueish colors) indicate clayey soil types, while low electrical conductivity (reddish colors) indicate sandier soils.

Apparent conductivities recorded using the EMI instruments show that soil electrical conductivities vary spatially in each pond. Figure 5 shows the soil apparent electrical conductivity (E_{Ca}) for all sensor depths across all six ponds (Fig. 5A – F). The electrical conductivity ranges from close to zero to 50 milli-Siemens/m (mS/m). Very low conductivity (typically associated with coarse-grain soils) is observed across all ponds in Figure 5A at 0.3 m depth except in the northern parts of P8 and P9. The red colored data points indicate a dry sandy soil, while yellow to blueish colors in the northern portions of P8 and P9 likely relate to soils with higher silt and clay content. For all ponds E_{Ca} increases with increasing depth, indicating an increase in soil moisture or fine-grain soils with depth. Data from deeper depths, show more distinct and spatially continuous subsurface features. A potential sandy channel is observed trending northeast-southwest across pond P10 (north side) into P11 and into P12 (red zone middle of pond) passing through the southeast corner of P13. This is a distinct feature extending from 0.5 m to 1.6 m (Figs. 5B-E), but has only a faint signature at 2.3 m depth (Fig. 5F). Another, low conductivity feature can be seen with the same orientation within P8 and P9.

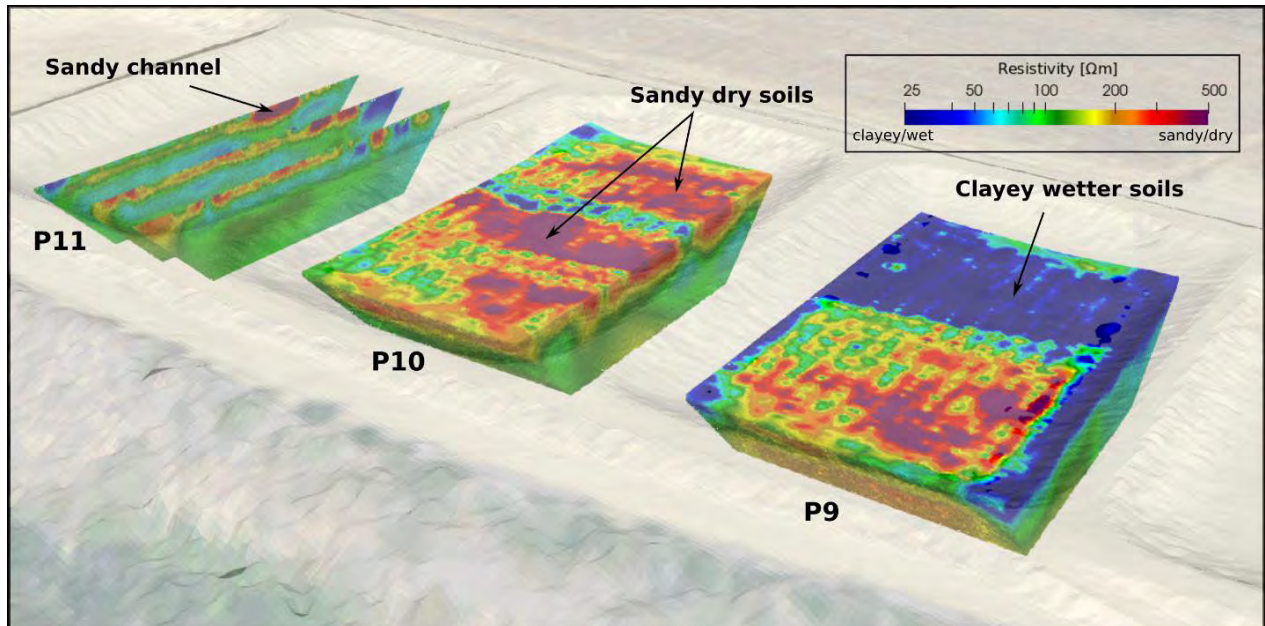
Figure 7. ERT results for ponds 9 – 11. Sandy soils shown in reddish colors, silty sands and silts in greenish-yellow colors, and clayey soils in blue. Variable surficial soils are roughly 1.5 m thick in all ponds then transition to more a more similar silty sand at depth.

The resistivity data of Pond 11 shows a resistive ($> 200 \Omega\text{m}$), shallow anomaly at the location where a sandy channel was mapped by the EMI data. This channel feature appears to widen towards Pond 12 and is less than 2 m deep. In general, the resistivity data of Pond 11 shows a thin ($< 1 \text{ m}$), high resistivity layer, which is interpreted to be a sandy soil, overlaying a less resistive layer ($< 60 \Omega\text{m}$) of 1 - 2 m thickness. Below this layer, resistivities increase again to values $> 100 \Omega\text{m}$. This can be interpreted as a sequence of sandy soils overlaying silty-sand above a sandy layer.

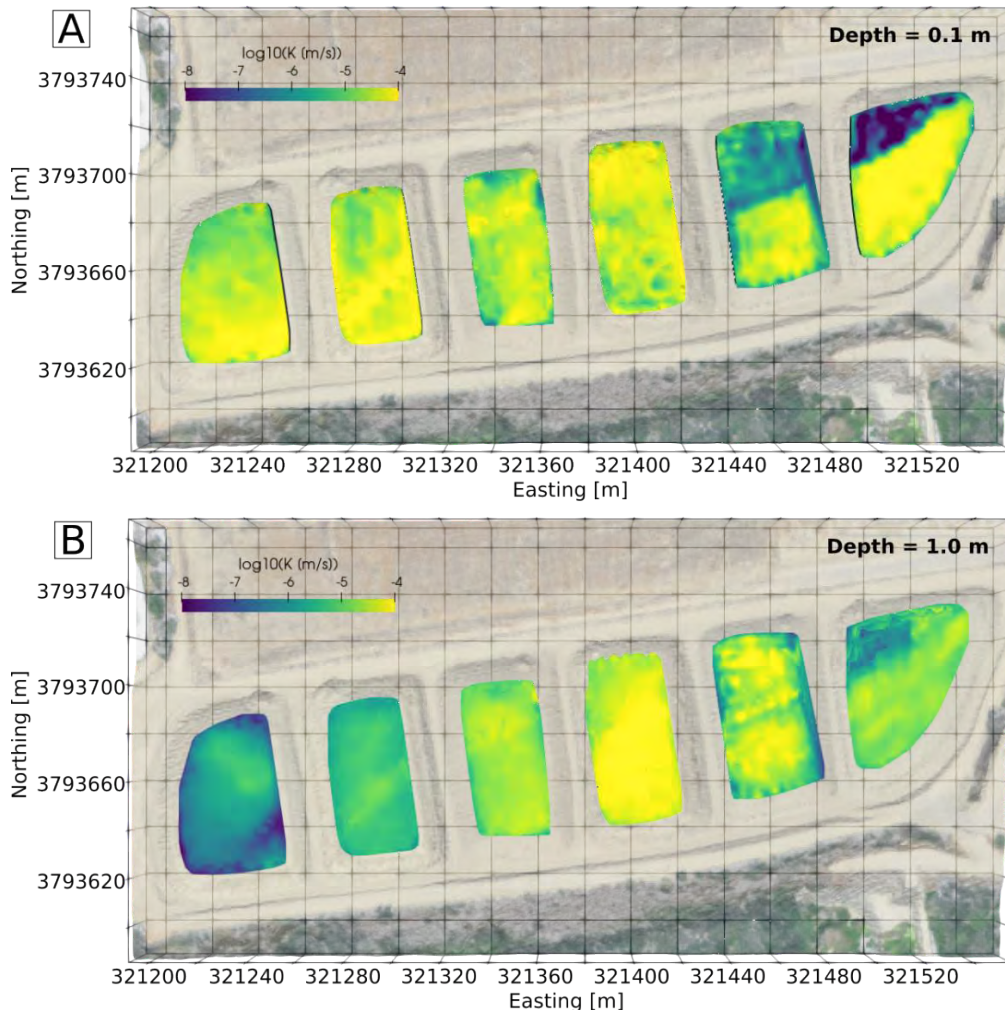
Figure 11. Spatial variability of hydraulic conductivity derived from a linear relationship established between observed K_{sat} and EMI measured electrical conductivity. Shown are two depth slices at (A) 0.1 m depth and (B) 1.0 m depth. Higher K_{sat} are shown in yellow and lower in dark blues.

In order to provide an estimate of the spatial heterogeneity of K_{sat} throughout the ponds, we established a relationship between electrical conductivity (obtained from the EMI) and measured K_{sat} . This is possible since the electrical conductivity of soils is known to be a function of grain size, which in turn relates to the hydraulic conductivity. A linear relationship was found to fit the data reasonably well (Fig. 11). Based on this, we translated the measured 3D models of electrical conductivity into K_{sat} . These distributions build the basis for a numerical estimation of recharge rates shown in Figure 11. In Figure 11A the spatial distribution of K_{sat} is relatively high (yellow colors) for surface soils down to 0.1 m across all ponds with the exception of low K_{sat} (dark blue color) soils on the north sides of Ponds 8 and 9. At deeper depths, Ponds 8 and 9 K_{sat} improve (Figure 11B) compared to Ponds 12 and 13.

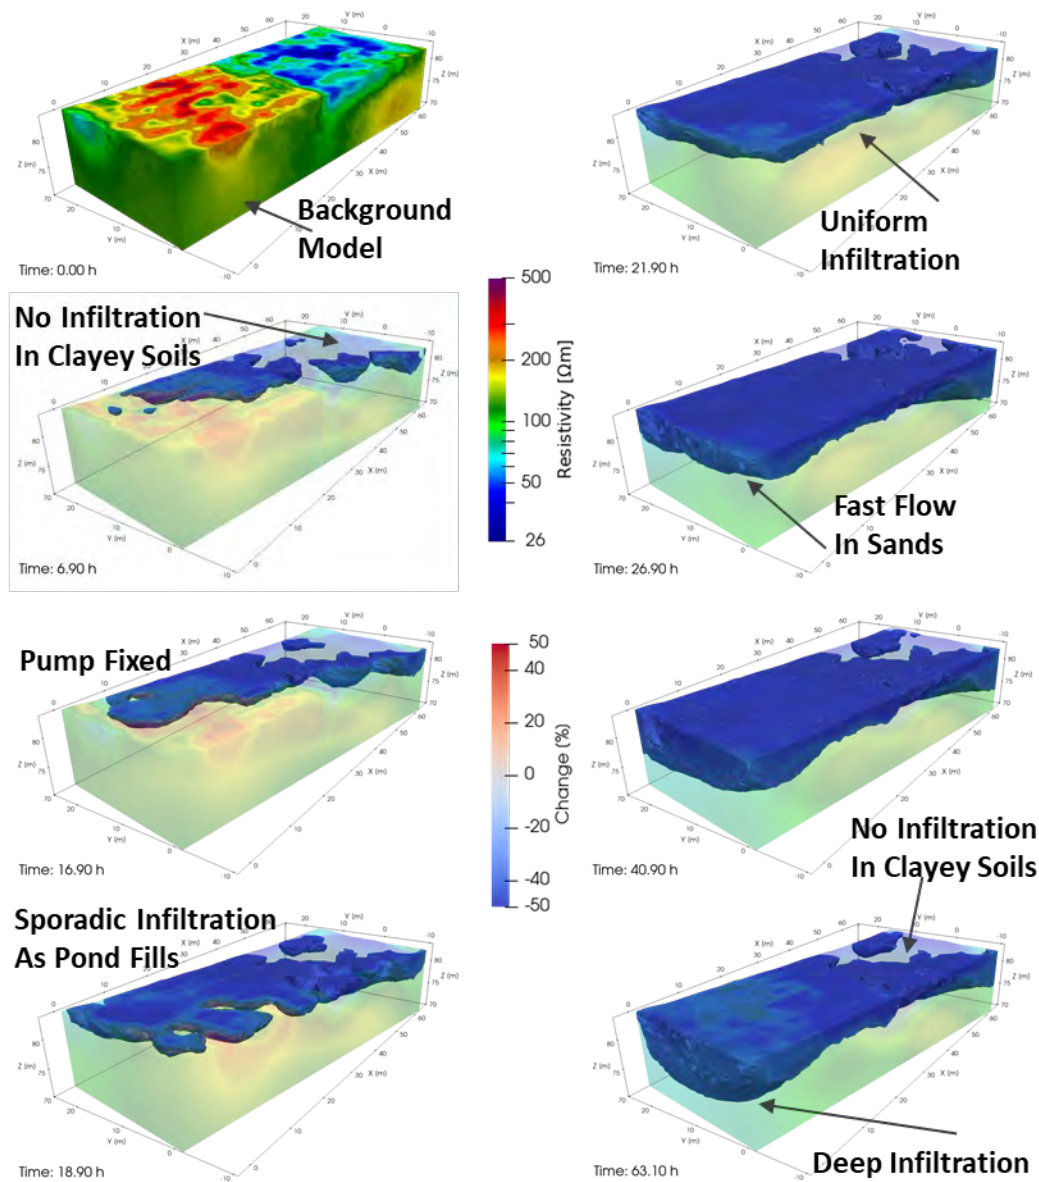
Figure 15. Pond 9 water infiltration mapping in percent change resistivity with the background resistivity model shown and then transparency applied. Sporadic fast path infiltration is observed as the pond fills. At +16.9 hours the broken pump was fixed and water application commenced. After the pond is filled fairly uniform infiltration is observed at +21.9 hours. Until the southern end sandy soils take over and recharge more of the water at +40.9 hours to a depth of 15 m. The northwest corner clayey soils zone never infiltrated water.

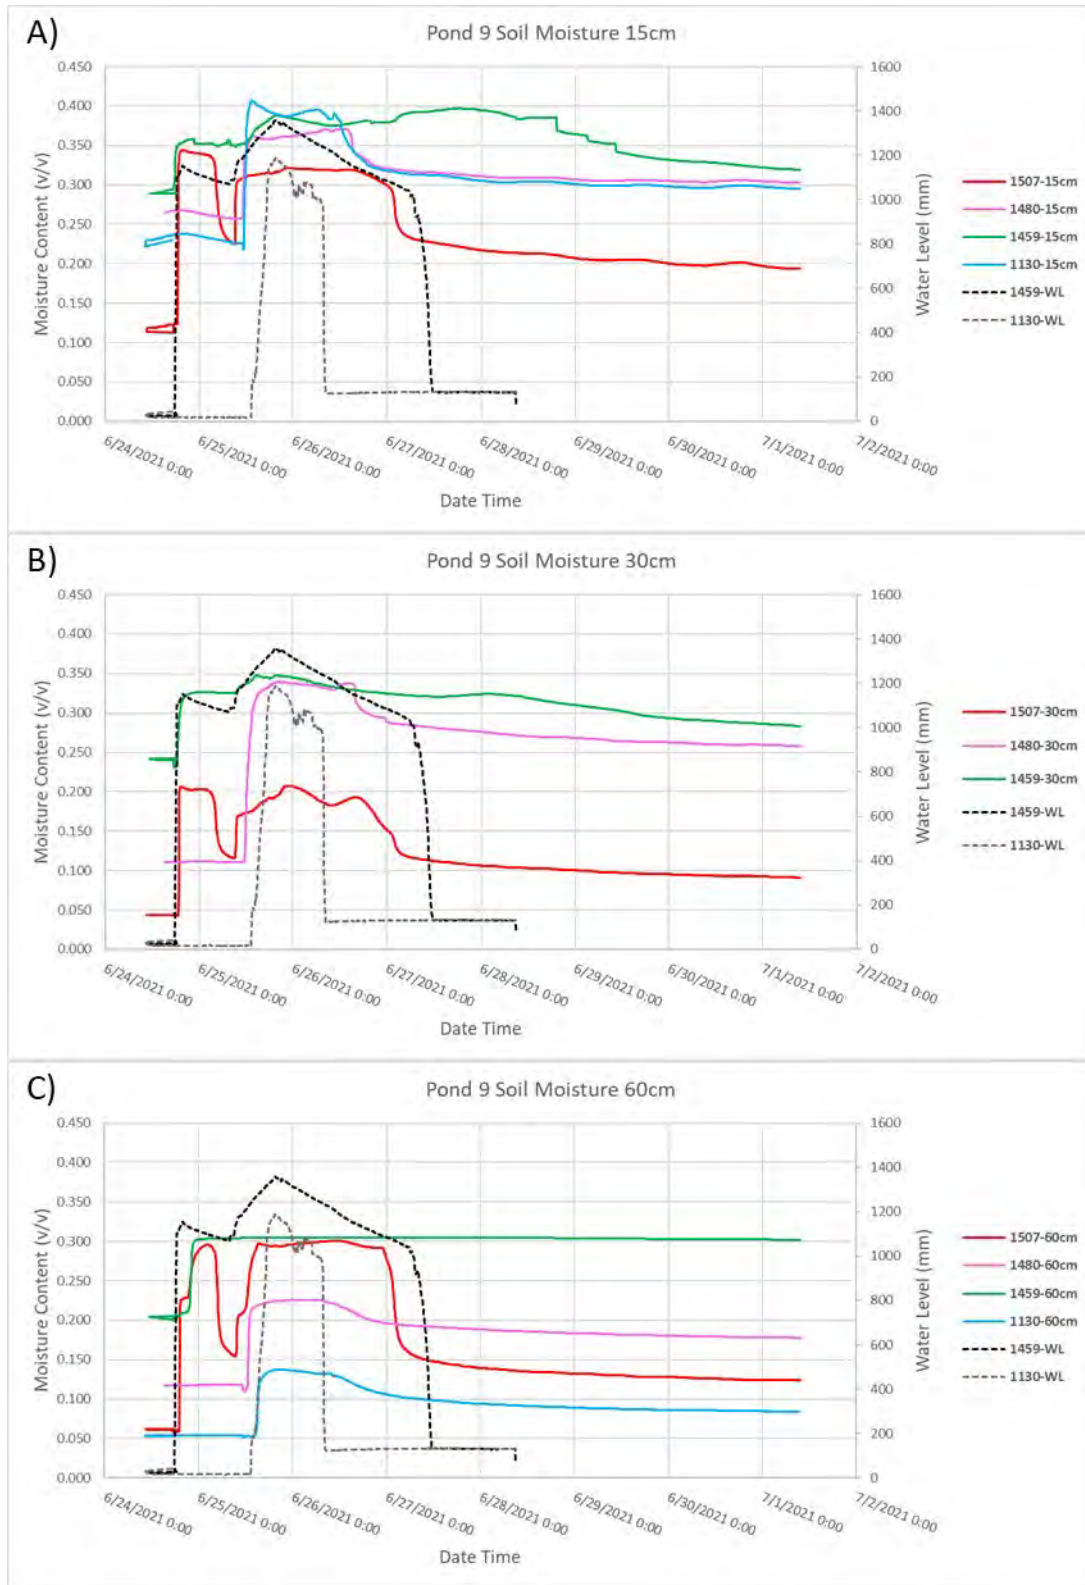
Figure 19. Shows the Pond 9 soil volumetric soil moisture responses at A) 15cm depth, B) 30cm depth, and C) 60cm depth. On the secondary axis is the water levels at two locations.

19). All sensors continued to monitor soil moisture levels for days after Pond 9 had emptied, these soil moisture values beyond June 28th give us an idea of the field capacity of these soils and insight about when the next water application could occur since all soils had drained. These results also highlight the infiltration complexity in different soil types and that most infiltration happens through preferential flow paths controlled by sandy soils. These soil moisture curves can also provide information the porosity of the sediments, after the soil moisture initial increase and all of the soil moisture curves become constant over time. If we assume that during that the plateaued (flat max) part of the curve represents full saturation of the soils then the water content is equal to the porosity. Following this logic, the soils in Pond 9 range in porosity from 30 – 40% for the sandy soils. In some cases, the curves in Figure 19 do not stay constant for very long and those should not be used to estimate the porosity.

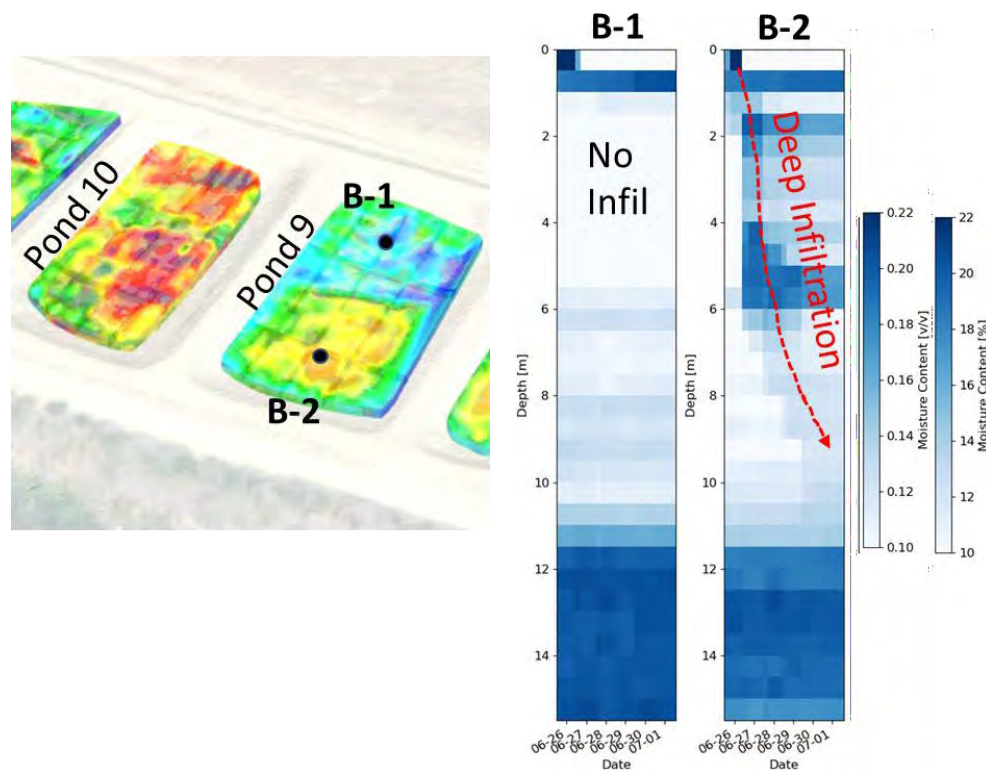
Figure 20. Pond 9 Neutron Probe soil moisture responses for B-1 and B-2. B-1 was located in the little to no infiltration zone containing fine grain sediments and B-2 was in the southern sandier soils. These plots show both the volumetric water content and the percent moisture content with

the same scales for interchangeable comparison. Little to no change observed in B-1 at all depths except 0 – 1 m. B-2 shows fast, deep infiltration down to 10 m. In some locations, for instance from 4 – 6 m background soil moisture was at 10% or less and increase up to 20%+ over time.

The neutron probe was lowered down the access pipe at 0.5m intervals to observe the changes in soil moisture in depth and over time. Figure 19 shows the location of the two neutron probe access holes in Pond 9 (B-1 and B-2). B-1 was located in the silty clayey northern end sediments and B-2 was located in the sandier southern end sediments. The soil moisture plots in Figure 20 show the change in volumetric soil moisture and moisture content in percent, plotted on the same scale. The x-axis shows the displays the times from before, during, and after inundation. B-1 observed little to no infiltration and B-2 observed changes in soil moisture from 10 to 20+%. Interestingly, quick infiltration is observed from 0-2 m, then a slight delay from 2-6m (but almost instantaneous response times). Between 4 and 6 m an increase of soil moisture up to 22% is observed and decreases over time and as that zone starts to decrease we see a slow increase in soil moisture from ~10% to ~14% between 6-11 m. A review of the B-2 soil log shows a silty, fine sand layer from 5.85 – 5.95 m. We suspect this finer sediment, low permeability layer causes the buildup of moisture observed from 4-6 m, but it slowly drains over the next few days as observed soil moisture increases over time in the depths between 6-11 m well after the all the water has infiltrated below the base of the pond.

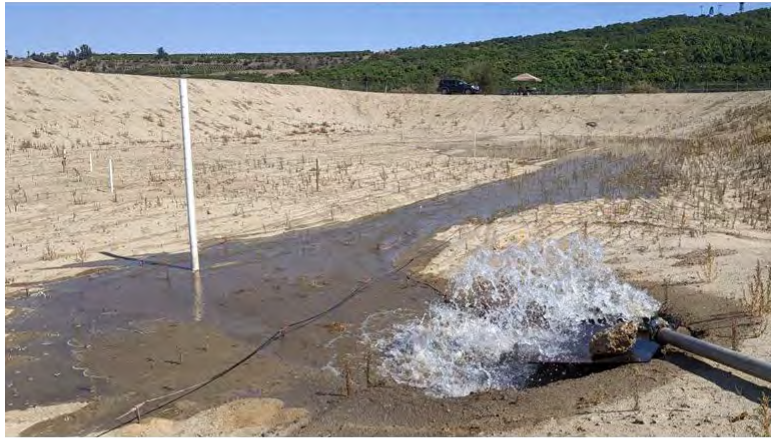
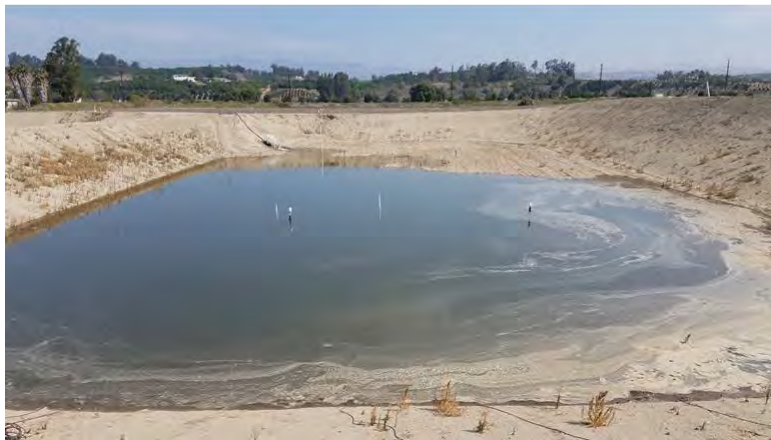
Pond 10 = 407k gallons (1.5 AF)

Figure 21. The filling of Pond 10 with 407k gallons (1.5 AF). The pond was never filled due to the high infiltration rates that were similar to the pump outflow rates.

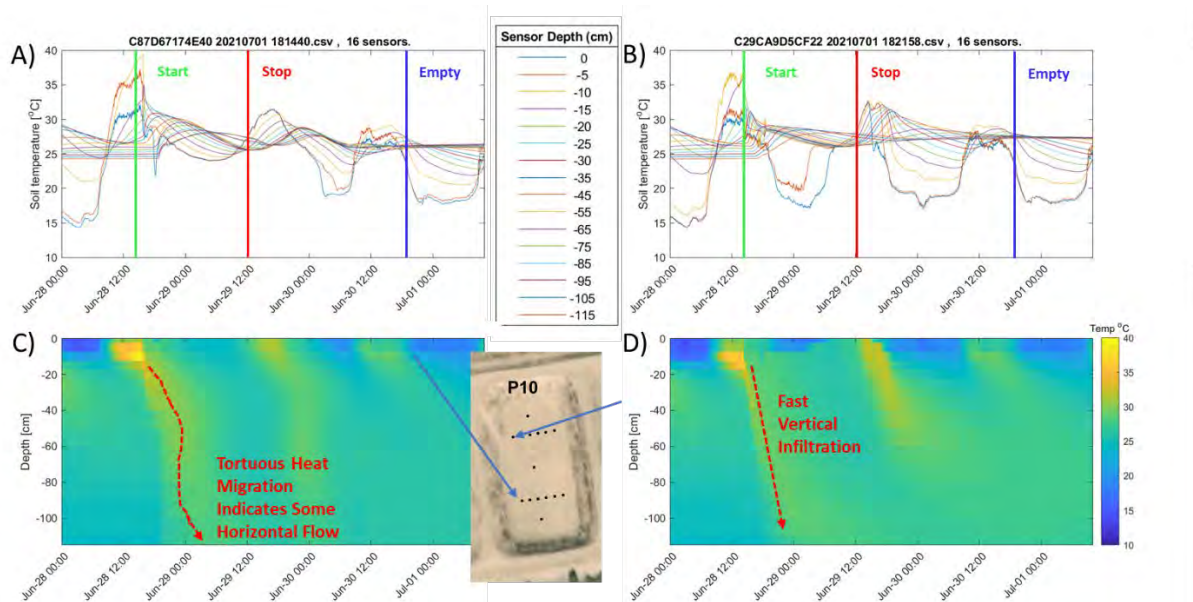
Figure 23. Pond 10 DTP thermal response examples in sandy soils. The start and stop of water application are shown in (A) and (B) by the green and red lines, and the pond empty is shown by the blue line. DTP probes show tortuosity in the heat migration through the subsurface (C) likely due to horizontal flow observed in the ERT data. Compared to linear heat movement through the subsurface (D) indicating vertical flow.

Fifteen DTP probes were installed in Pond 10 shown in Figure 18. Again, these probes were a new design from the characterization phase probes and had an additional four thermal (16 total) sensors all spaced 5 cm apart. Complex subsurface flow was observed in the earlier ERT results (Figure 22). This was confirmed by the DTP results too and all of the thermal response images are shown in Appendix B. The start and stop time of water application are indicated by green and red lines, respectively (Figure 23 A & B), while the time that the pond was completely empty is shown as a blue line. The tortuosity of the heat pulse through the subsurface in Figure 23C (curvy red dashed line) is likely the result of horizontal water movement in addition to vertical flow. This result is exciting because it captures complex water movement in the subsurface, but it cannot be used for estimating 1D infiltration rates from the thermal sensors because it is not purely vertical flow; but, given the cheap cost of these probes many probes can be placed throughout the ponds to ensure that only vertical flow is captured (Figure 23D) in order to estimate infiltration rates.

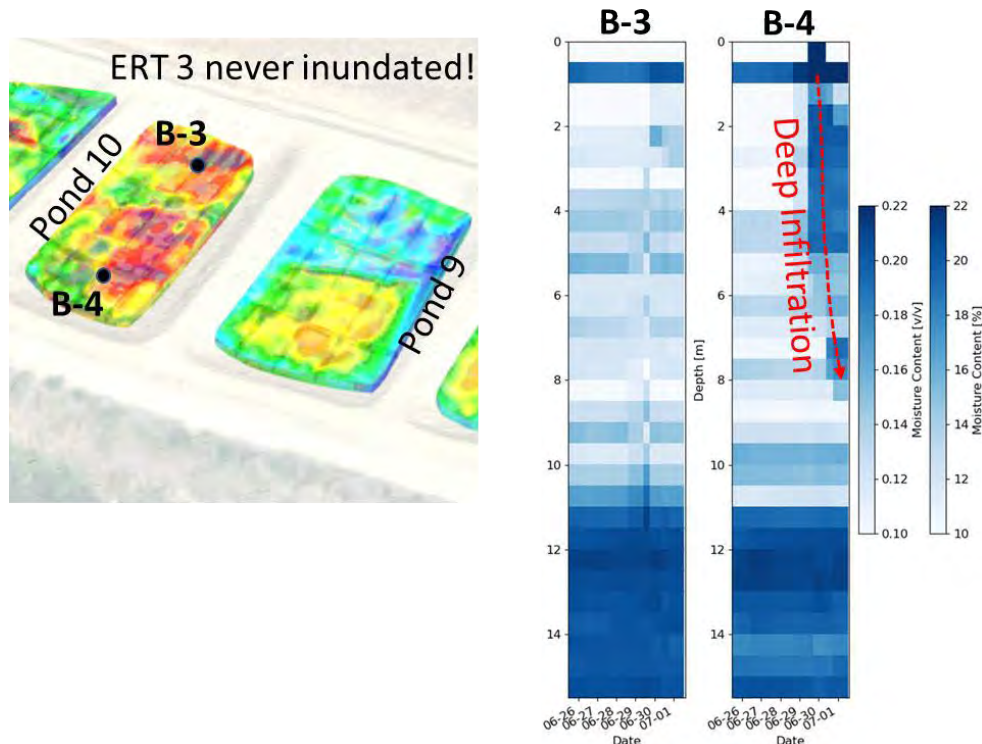
Figure 25. Pond 10 Neutron Probe soil moisture responses for B-3 and B-4. Both B-3 and B-4 are located in sandy soils but B-3 was in the area of the topographic high and was never inundated. Therefore, no changes are observed in the soil moisture along borehole B-3. B-4 shows deep infiltration (red dashed line). Soil moisture increases from ~10% to ~22% from 0-9m bgs. Below 9m soil moisture is somewhat constant.

Figure 25). Soil moisture increase from 10% (background) up to ~22% were observed down to 9m. B-4 was on the boundary of the sandy zone that covered the southeast portion of the pond and contained slightly more fine sediments that reduced infiltration depths. When looking at the ERT +45 hours in Figure 21 the deepest infiltration is observed in the southeast corner. B-4 was on the transition to the finer soils on the southwestern side of Pond 10. The ERT response there shows infiltration down to ~10m which agrees with these neutron probe soil moisture results.

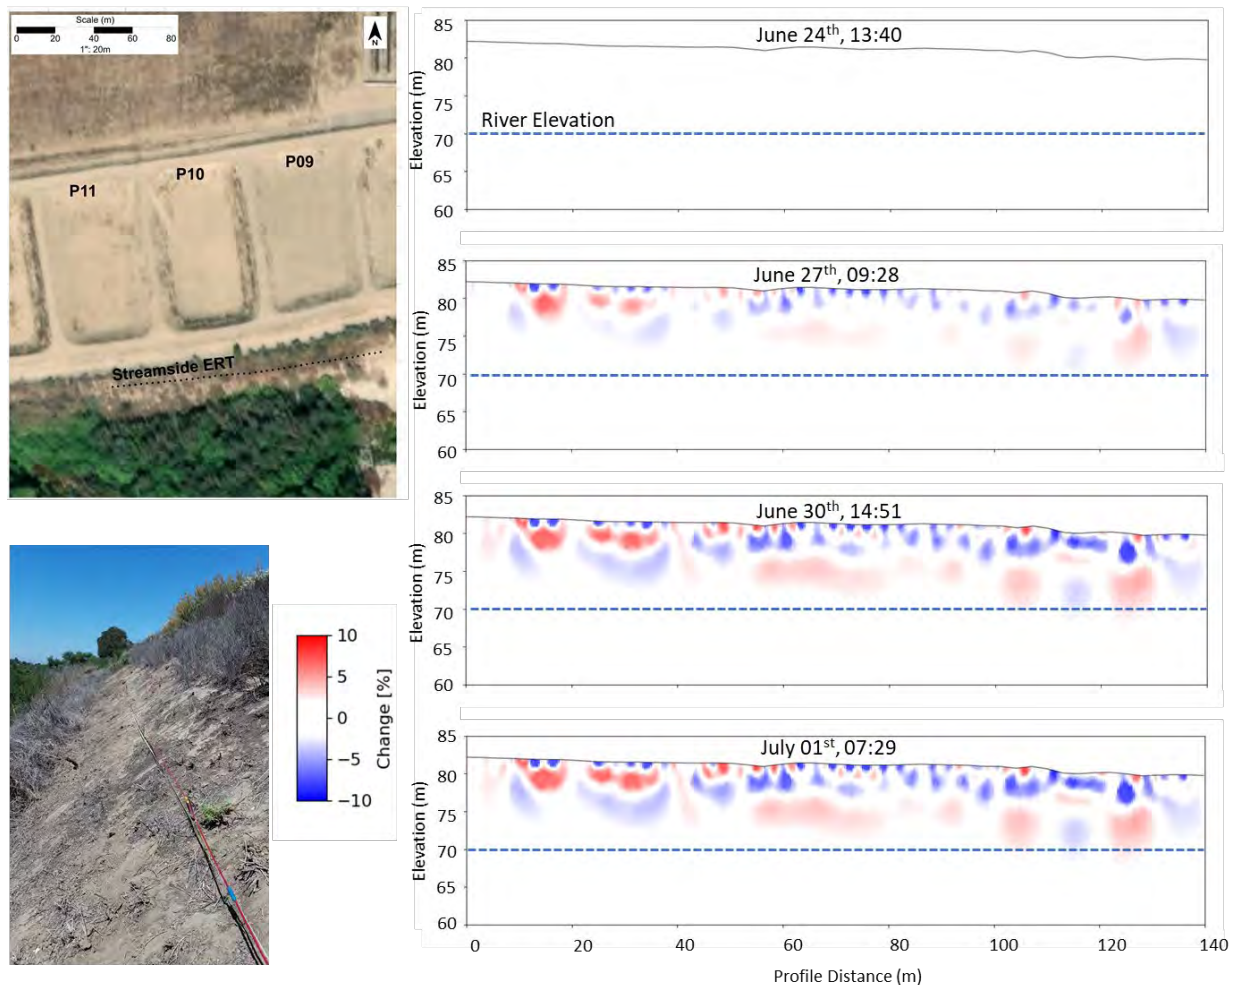
Figure 26. shows the location of the streamside ERT profile to monitor for water flow back into the river. Eleven time series datasets were collected from June 24th to July 1st and are shown as a percent change from the baseline dataset collected June 24th before all water applications. The top of the ERT profile is at the same elevation of the ponds and the river elevation is shown as a dashed blue line. The small percent change in resistivity indicate no water flow back into the river when compared to changes during the flooding events in Figures 15 and 22.

The river elevation is 10 – 12m below the base of the ponds. Results from the ERT timeseries show no indication of water flowing from the ponds to the river during water infiltration. Given the amount of water applied during both experiments, and the percent change of greater than 50% in Figures 15 and 22 observed during both flooding events, we would expect to see large changes in the resistivity values between the ponds and the river if the recharged water was migrating into the river. The maximum changes in Figure 26 throughout the whole two weeks was less than 10%. Furthermore, we would expect to see a large feature visible within the plane, but only sporadic small changes are observed. These results indicate that the infiltrated water does not migrate directly back into the river.

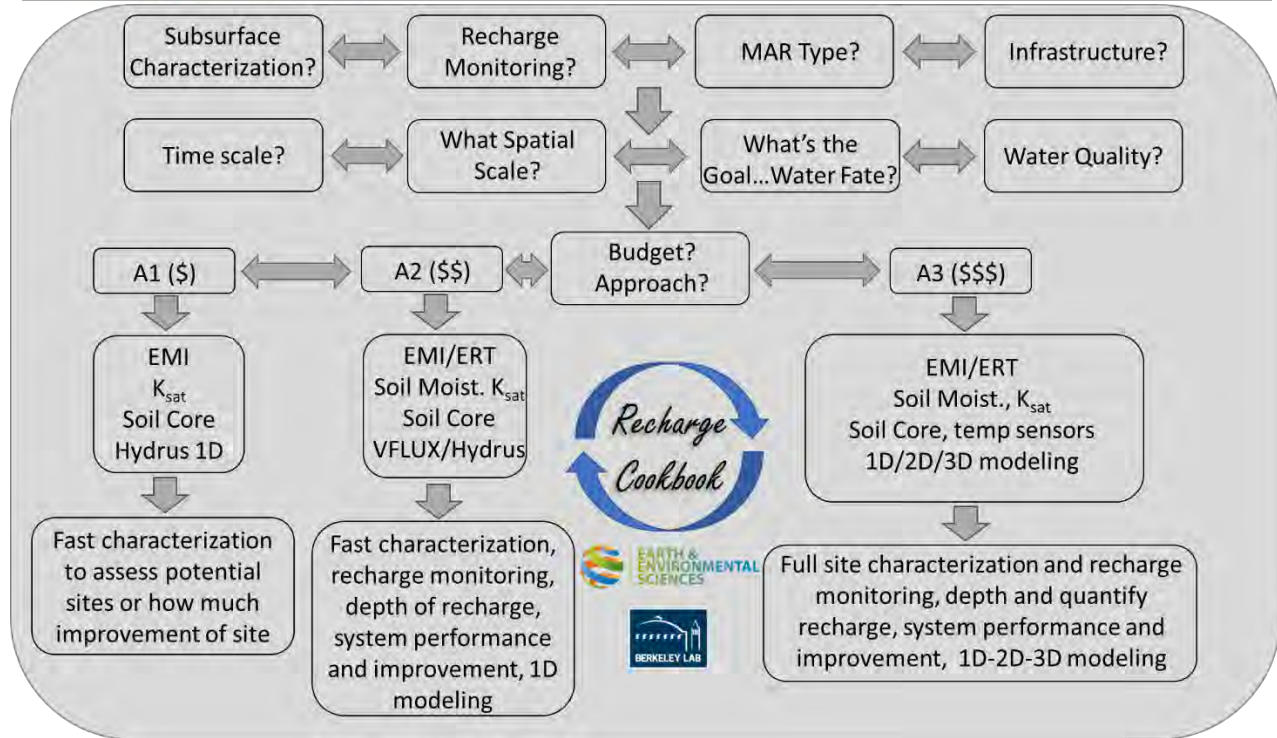
Figure 31. LBNL Recharge Cookbook guidance document for planning groundwater recharge site development, monitoring, improvement, etc. based on goals and budget.
