Kennedy/Jenks Consultants

Thousand Oaks Groundwater Utilization Pilot Study

12 October 2020

City of Thousand Oaks

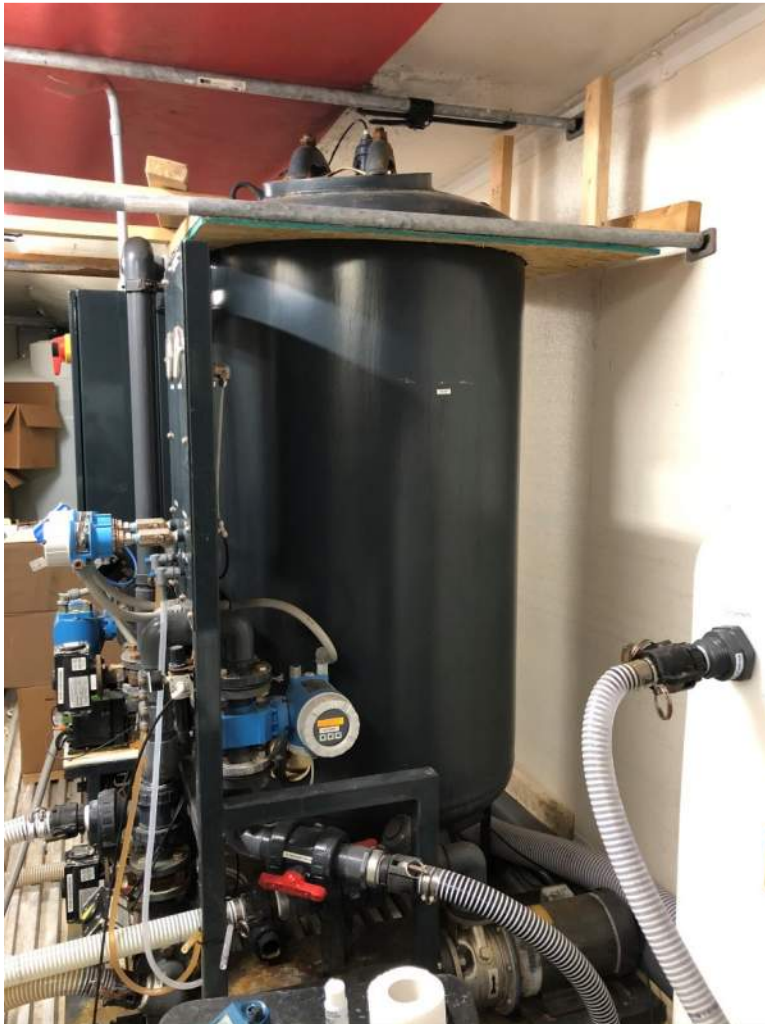
Sodium metabisulfite, sulfuric acid, and antiscalant will be added for chemical conditioning prior to the Conventional RO system. Sodium metabisulfite is required to remove any residual chlorine as chlorine can damage the RO membranes. Sulfuric acid lowers the pH, reducing the Langelier Saturation Index (LSI), which limits the potential of calcium carbonate scaling in the RO. Antiscalants inhibit the formation and precipitation of scale on the RO membranes. Cartridge filtration will provide supplemental protection of the RO membranes from particulates that may be present in raw water.

Figure 2: Greensand+ Media Filter

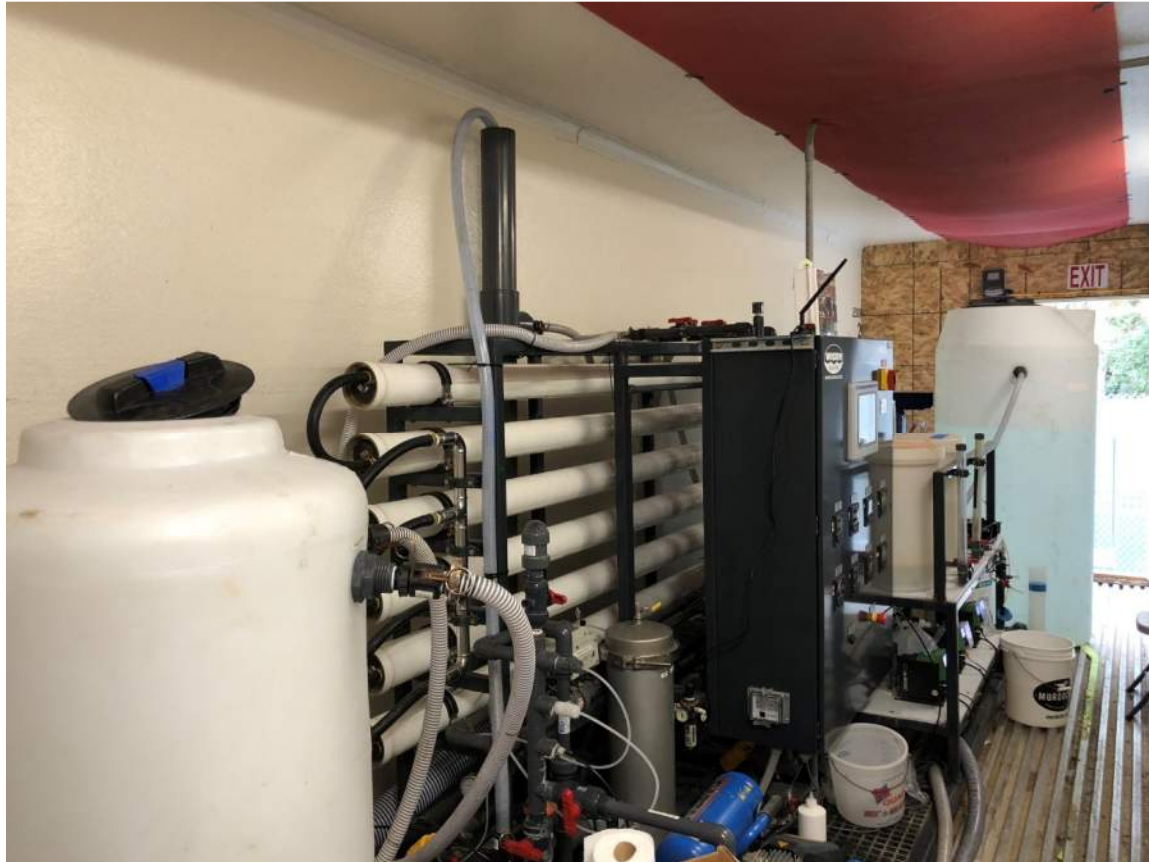
support racks installed to accommodate the required membrane area at a given design flux and recovery. For process flexibility and redundancy, it is often desirable to have multiple trains compose the overall system flow requirement. For the LRGC treatment process, a two-train system, each supplying 50 percent of the treatment flow, is recommended.

Figure 3: Wigen Reverse Osmosis System

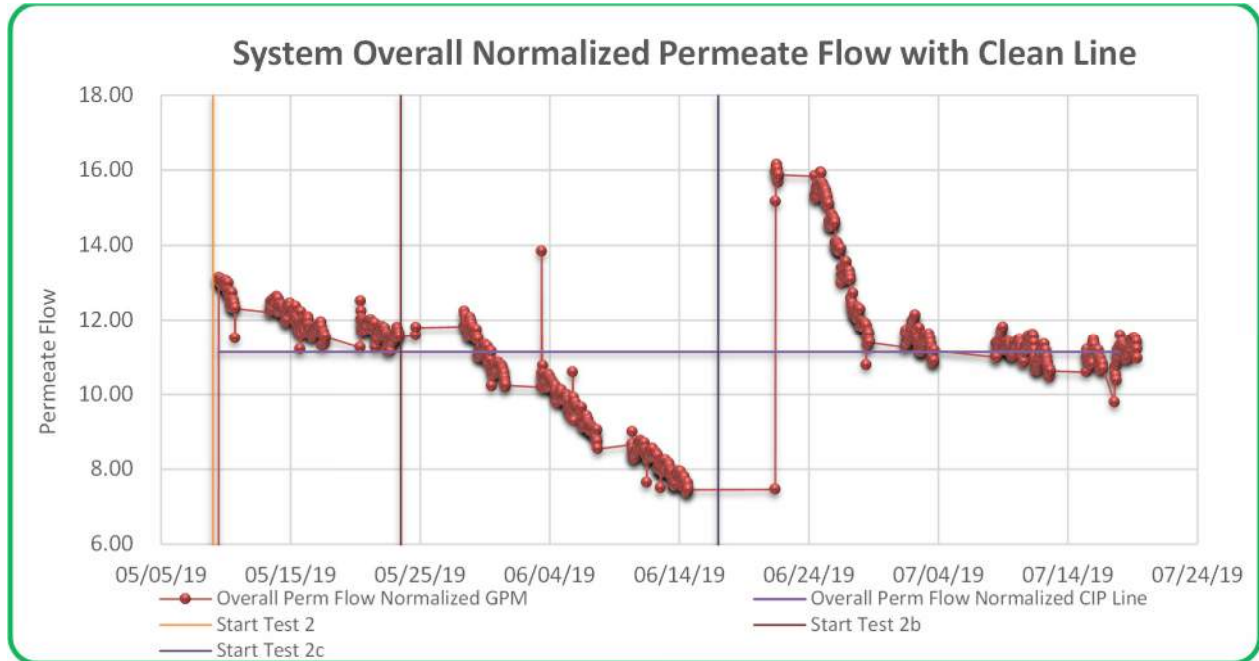
and ran for four weeks. Test #2C was shutdown to begin Test #3, not due to exceeding the CIP threshold, but to start Test #3 and allow for a direct comparison between the newly commissioned CCRO system and the Conventional RO system.

Figure 14: Conventional RO Test #2 Performance Summary

For the start of Test #2C, operational changes were made to the Conventional RO startup procedure. Throughout the pilot, the system was shutdown Friday afternoon and restarted Monday morning. Over the weekend, well water sat stagnant in the feed line, cooling to ambient temperatures. During startup, the colder feed water would cause the Conventional RO system to exceed the recovery setpoint, resulting in silica concentrations above the saturation limit. As even short periods above the saturation limit can quickly scale the membranes, this procedure was negatively impacting the performance of the membranes. Additionally, water quality results confirmed the silica concentrations were higher than the historical data (**Table 9: Historical vs Pilot Water Quality**). Updated Conventional RO projections using the new water quality concentrations found that at normal feed temperatures (greater than 70F) and a recovery set point of 79%, the saturation index for silica dioxide exceeded 100% saturation, meaning that scaling was very likely to occur. At the lower feed water temperatures during startup, the saturation indices further exceeded 100%.

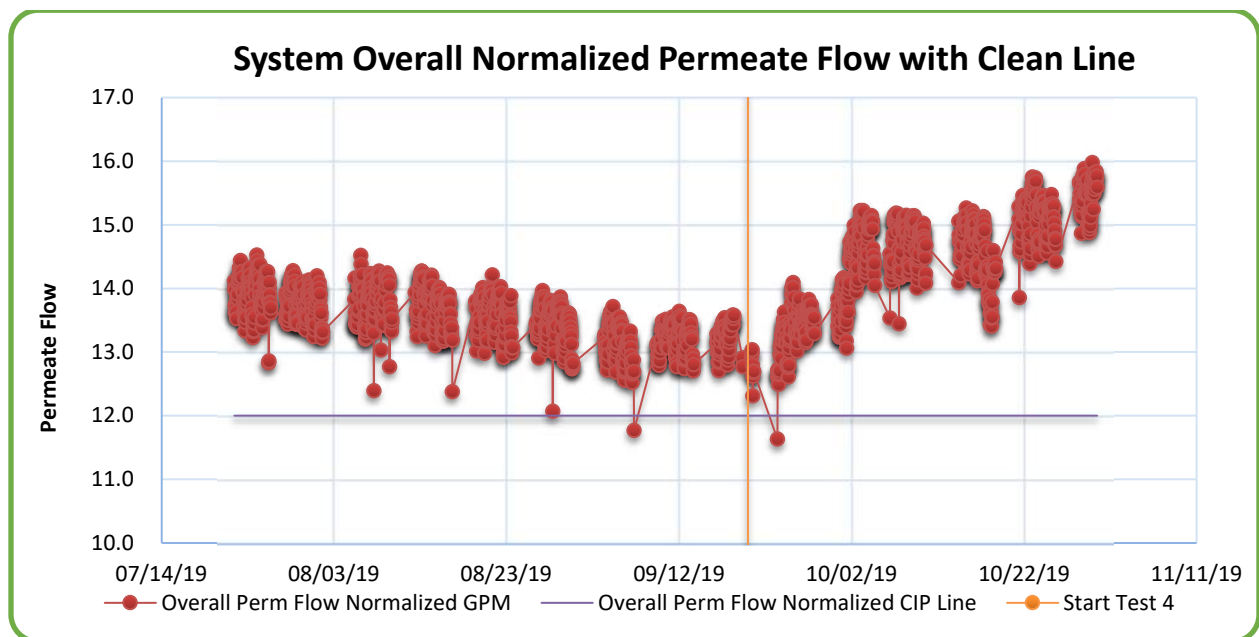
The Conventional RO data indicates the membranes may have been damaged by sodium hypochlorite (chlorine) at different points during Test #4. Breakthrough of sodium hypochlorite is measured as ORP (mV) and feed values greater than 600 mV occurred the beginning of Week 9, Week 10, and at the end of Week 14. Corresponding increases in conductivity (salt passage) followed each instance of elevated feed ORP. Both increased salt passage and lower feed pressures are likely a result of chlorine damage to the membranes during Test #4. Further information can be found in the Test #4 report.

Figure 17: Conventional RO Test #4 Performance Data

The Conventional RO system did not meet its runtime goal as the salt passage exceeded requirements. The degradation of the membranes could have been prevented if an ORP alarm/shutdown was included in the system. It is recommended that the full-scale system alarm/shutdown if the feed ORP exceeds a certain threshold for a defined period of time.

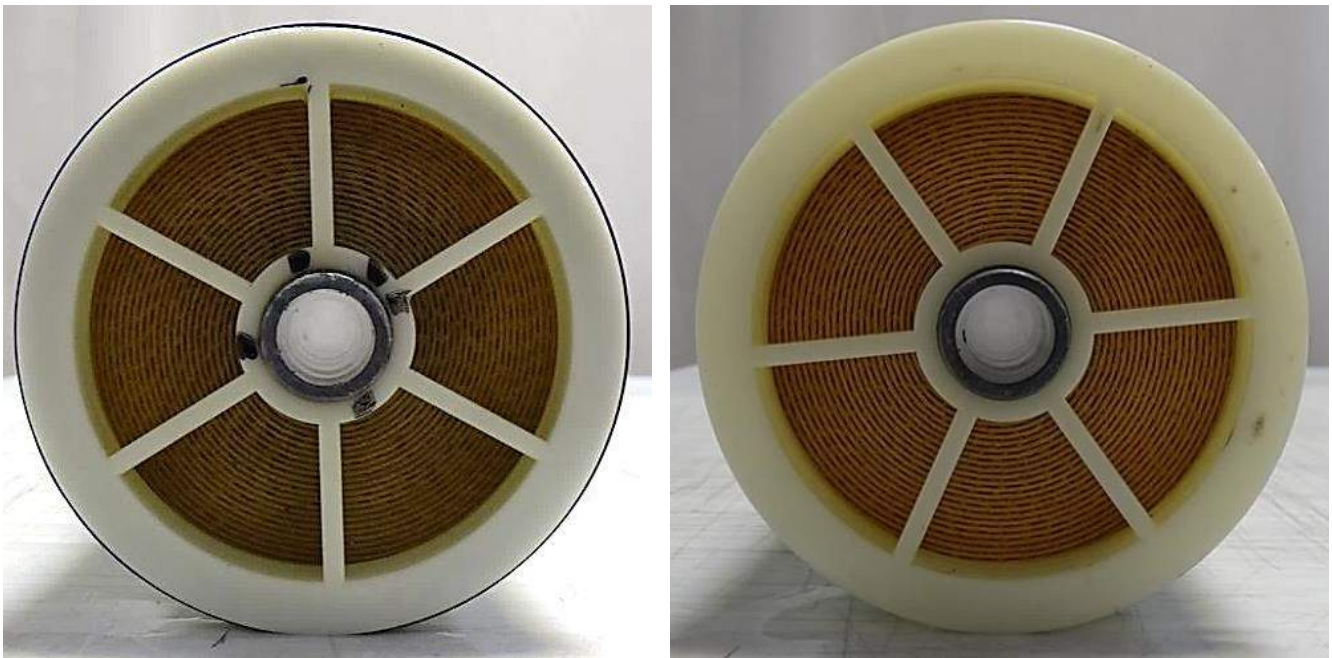
Both ATDs were in good condition and free of visible fouling.

Image of the feed (left) and concentrate (right) ATD of SN 2190321127

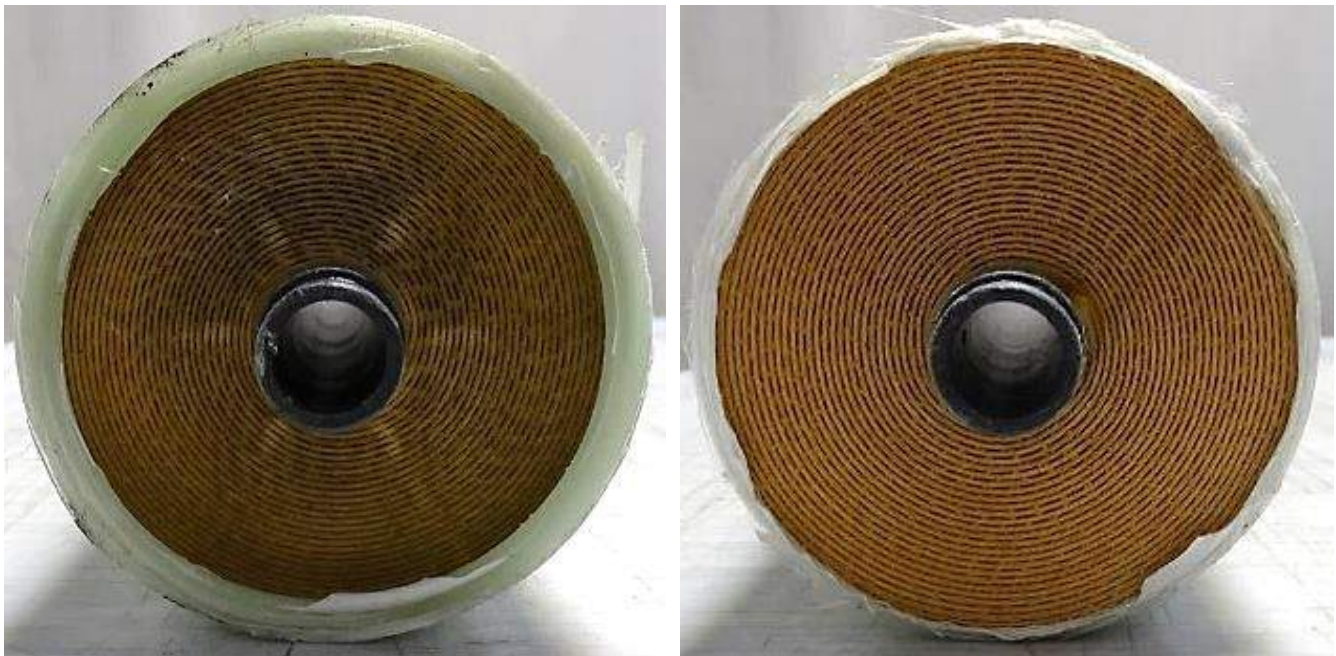
The feed scroll end displayed a light layer of tan-colored foulant material. Additionally, pressure marks from the ATD were observed on the feed scroll end. Despite this, both scroll ends were in good working condition.

Image of feed scroll end (left) and concentrate scroll end (right) of SN 2190321127

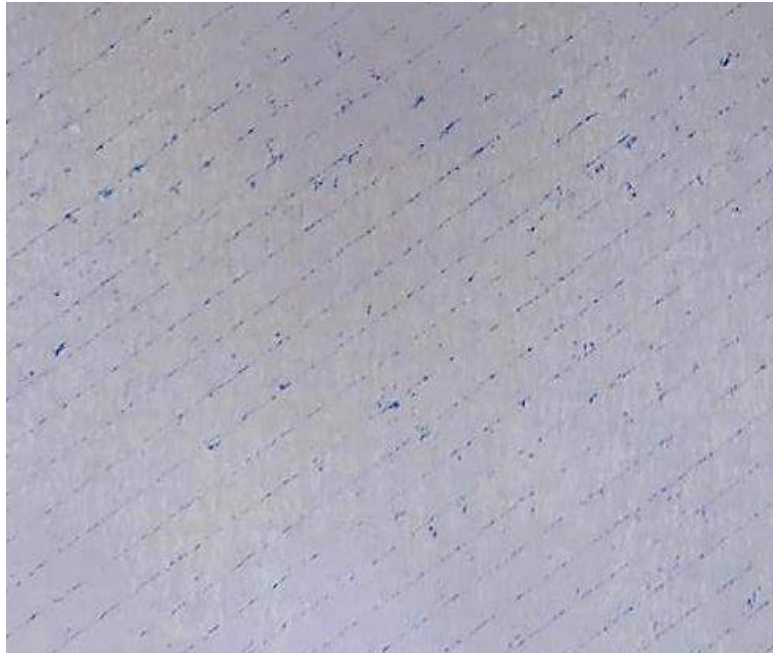
Dye testing produced an even pattern of light dye uptake accompanied by increased dye uptake in areas corresponding to the feed spacer contact points which is indicative of physical damage (e.g. presence of granular particulates).

Image of dye uptake on the membrane surface

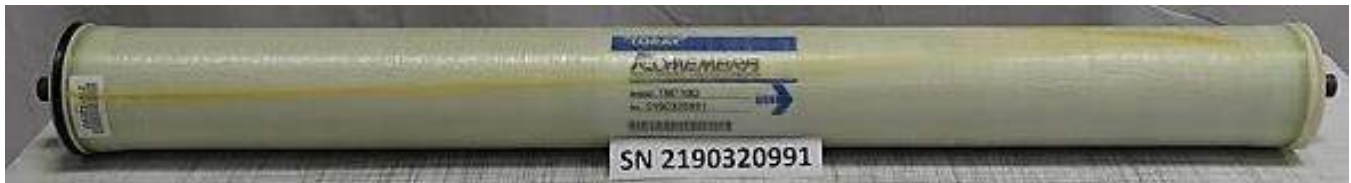
Although the fiberglass casing had two yellow-colored streaks running parallel to the permeate tube; the casing was free of any performance-altering defects.

Fiberglass casing of SN 2190320991

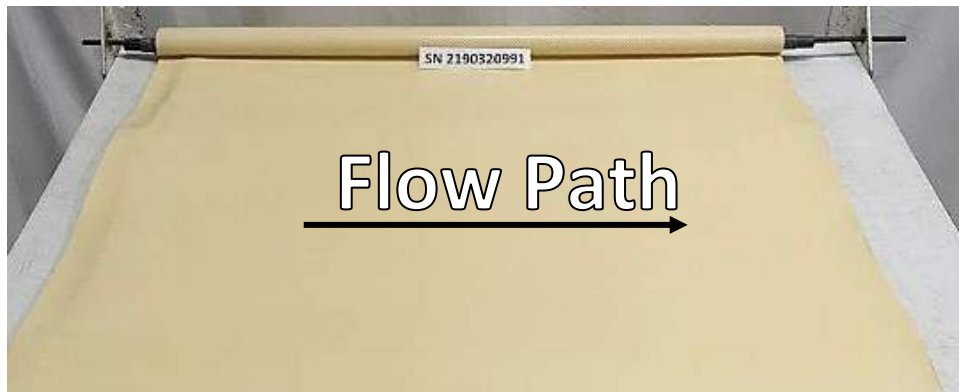
The exposed membrane surfaces exhibited a thin layer of fine-granular foulant material evenly dispersed throughout. No visible defects were noted upon inspection.

Exposed membrane surface of SN 2190320991

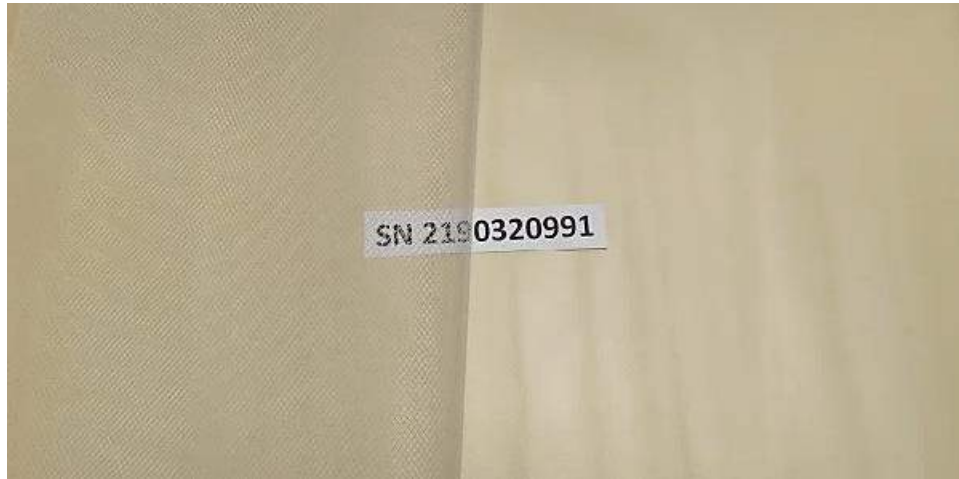
The feed spacers were free of foulant blockage and in good mechanical condition.

Image of a feed spacer of SN 2190320991

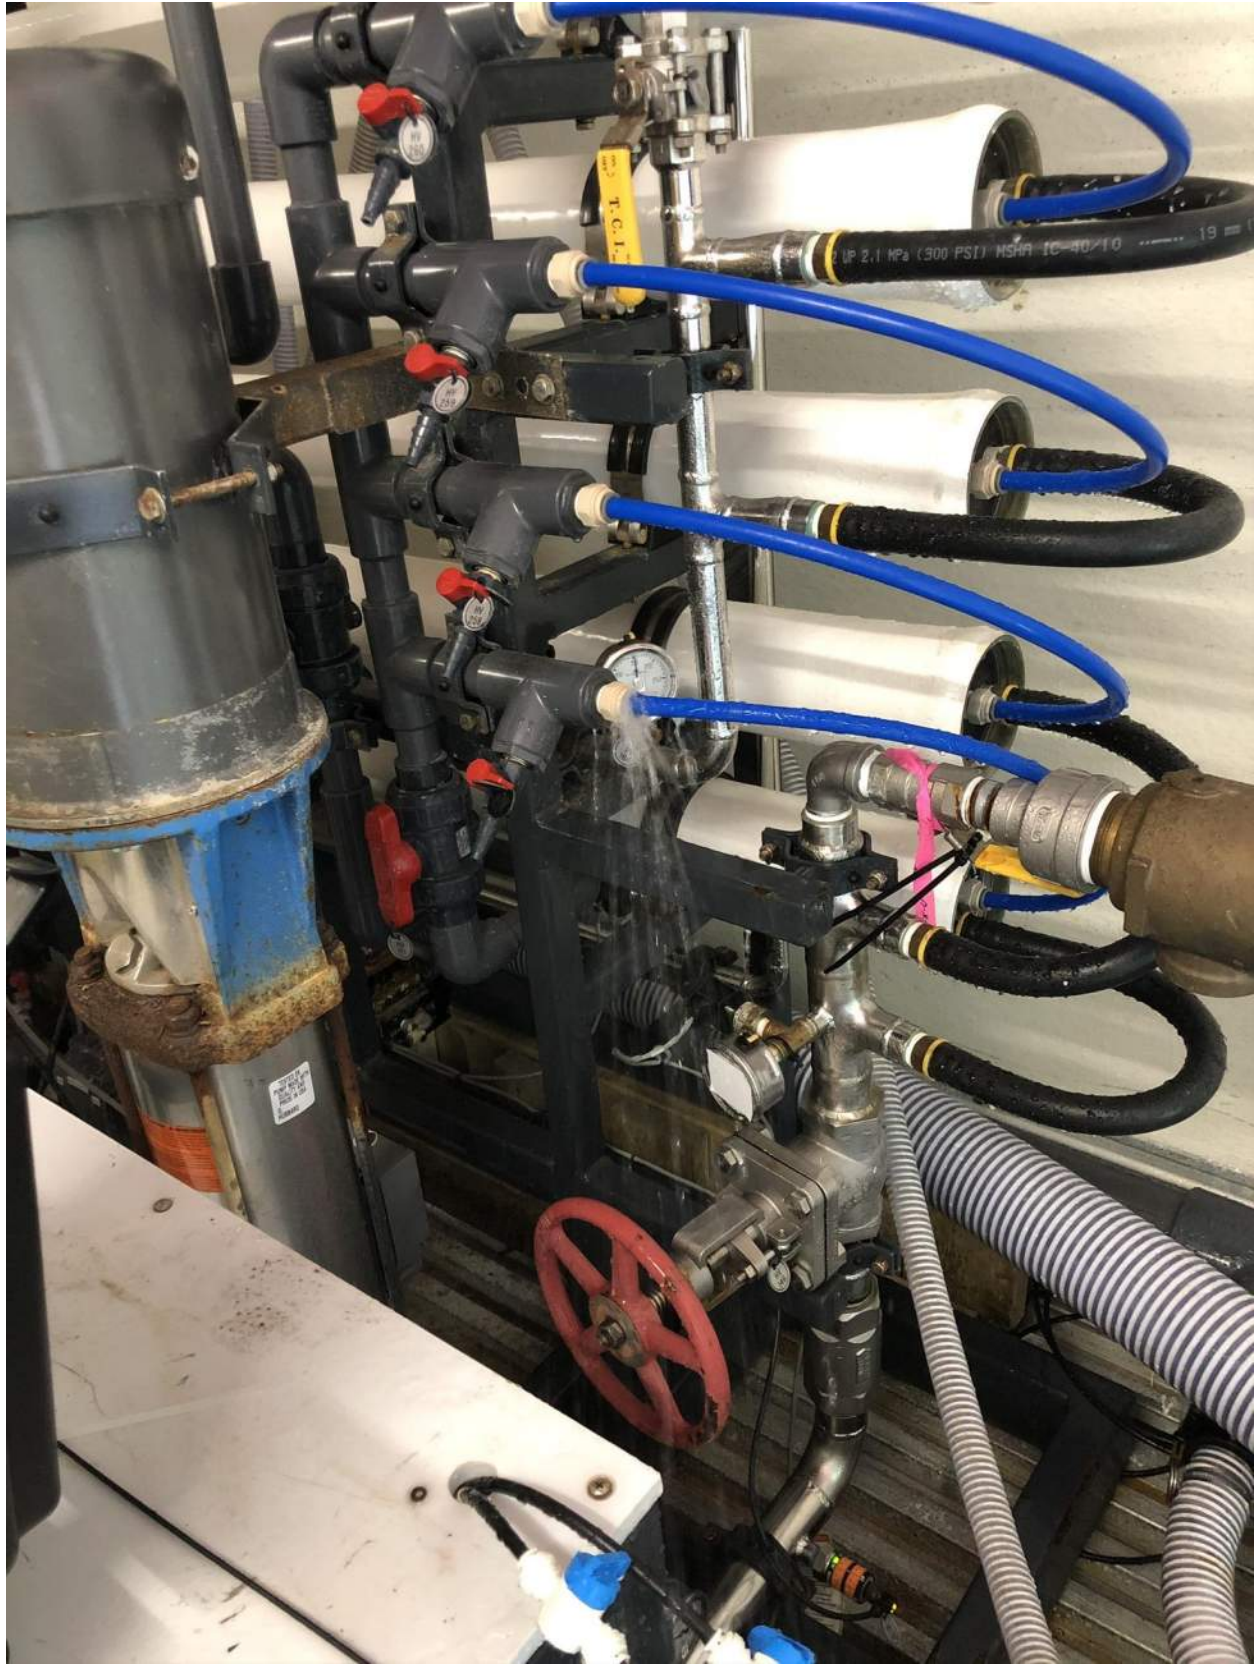
Conventional RO Photo 11 Leak at Membrane End

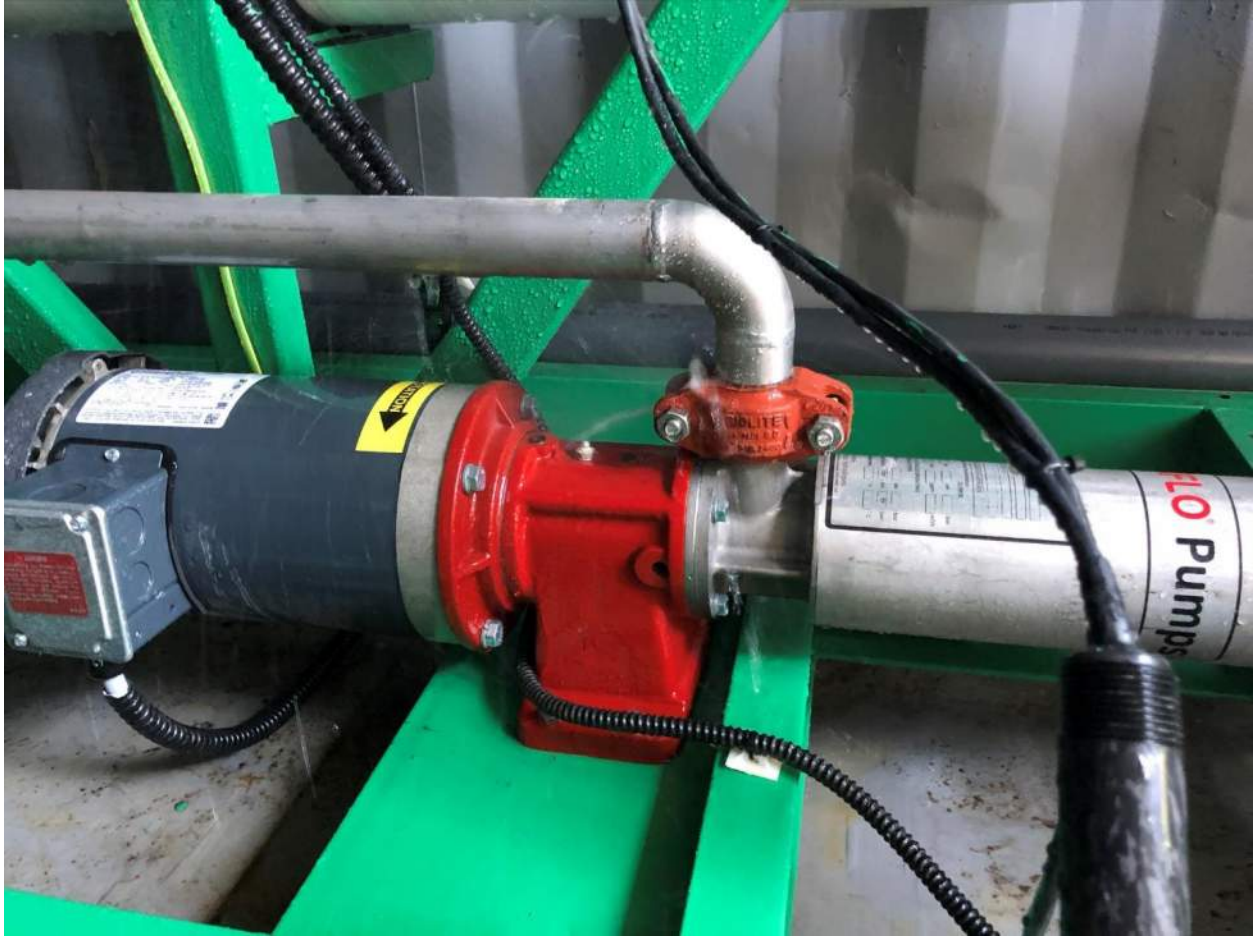
CCRO System Photo 6 Circulation Pump with Gasket Leak
