Carlsbad Desalination Plant Wedgewire Screen Pilot Study August 31, 2022

Phase 3 – Wedgewire Screens

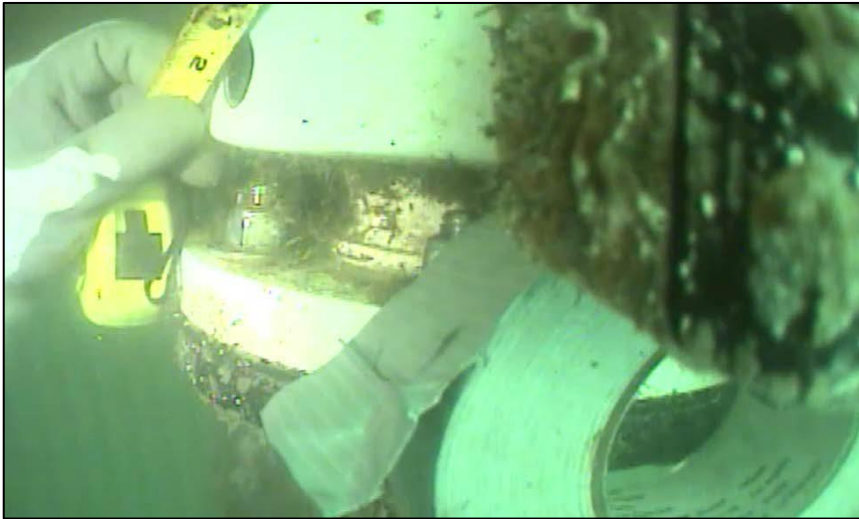
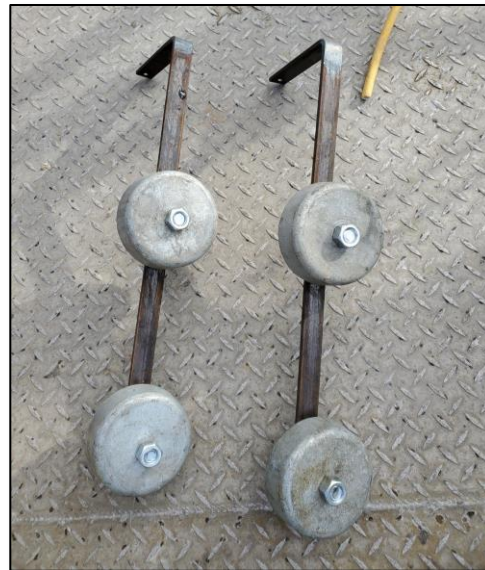
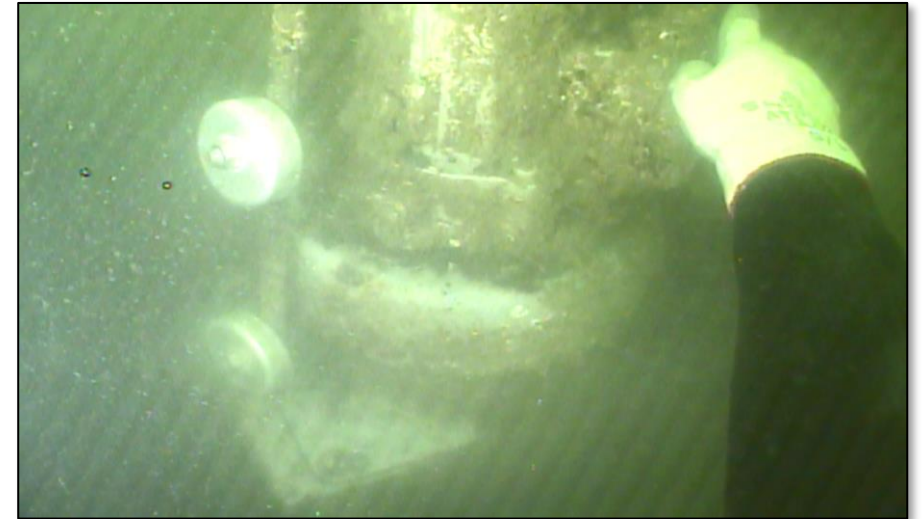
General

- Equipment maintenance in the Lagoon is a challenge:
 - cathodic protection, flow meters, pressure transducers, camera, umbilical anchoring, etc.

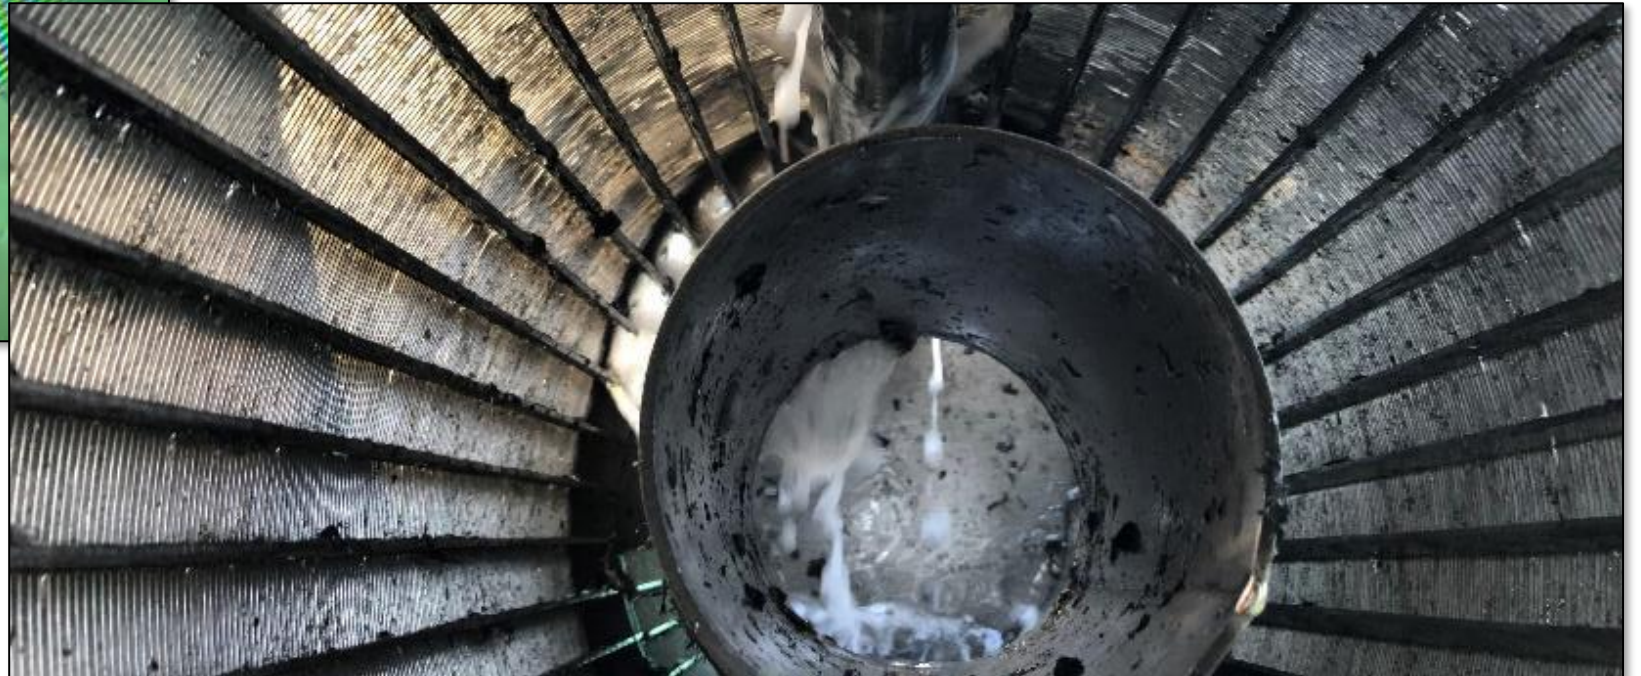
Passive WWS after thorough cleaning

Passive WWS (Super Duplex Stainless)

- Exterior fouling accumulated within one month (**Note:** screen is not copper nickel)
 - Exterior fouling was soft growth and was easily removed manually by divers
 - Airburst was effective for free-floating debris, but did not clear attached biofouling
- Interior inspection began after 6 months of operation
 - Substantial interior fouling accumulated since interior not cleaned monthly – airburst was operating for most of the 6-mo period
 - Progressed from soft to hard growth (mussels)
 - After monthly interior cleaning began, interior fouling was soft growth and was easily removed by divers (manually/with pressure washer)
